Manhole Inspection Summary

Manhole # S35S__070MH

Insp Date: 1/29/08 3:13 PM

Location Address: **1211 s.charles st**

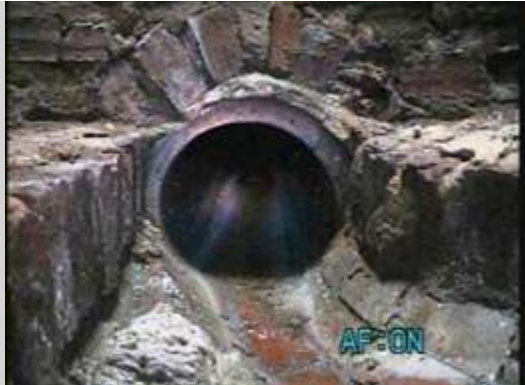
12 O'Clock Outflow

8 in. Circular Gravity Sewer
Pipe Out @ 12 O'Clock

Infiltration: **None** Pipe Seal Cond: **Unknown**
